# Morgan 3-Wheeler A Buyer's Guide

Andrew Warren

## **Introduction**

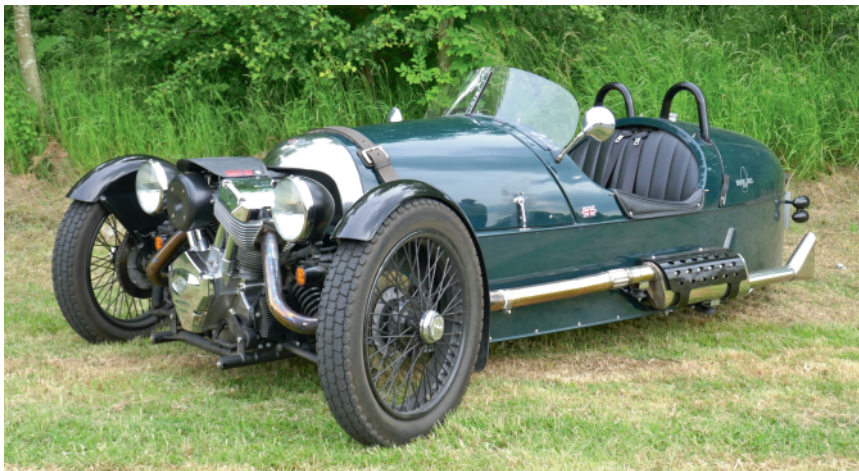
*Figure 1 Brooklands Special Edition showing special exhausts and the Fairbourne aftermarket windscreen.*

Special editions usually command a premium over standard cars. They have cosmetic enhancements and often include optional extras as standard. They are usually mechanically standard. Editions include: Superdry, Gulf, and 110th Anniversary models. The exception to this is the Brooklands Special Edition which includes a Brooklands-style exhaust system complete with fish-tail finials (Figure 1).

Unfortunately, the original systems were poorly designed and manufactured with many exhaust systems cracking after just a few hundred miles. MMC redesigned the system to have three mounting points on each side, which appears to be more robust. However, this upgraded exhaust system is quite expensive and availability is not guaranteed.

Fairbourne Carriages were the first to offer a full width screen (Figure 1) to replace the standard aero screens; MMC introduced their own version in 2016. Either of these options provides for more pleasant driving, especially when driving without a helmet. The Fairbourne screen is arguably superior because it's wider and higher. However, the MMC version is very nicely finished. There are no wipers on a M3W so both versions can cause visibility issues in wet conditions unless you are tall enough to look over the screen. Many owners prefer to stick with the original aero screens for the 'full M3W experience'!

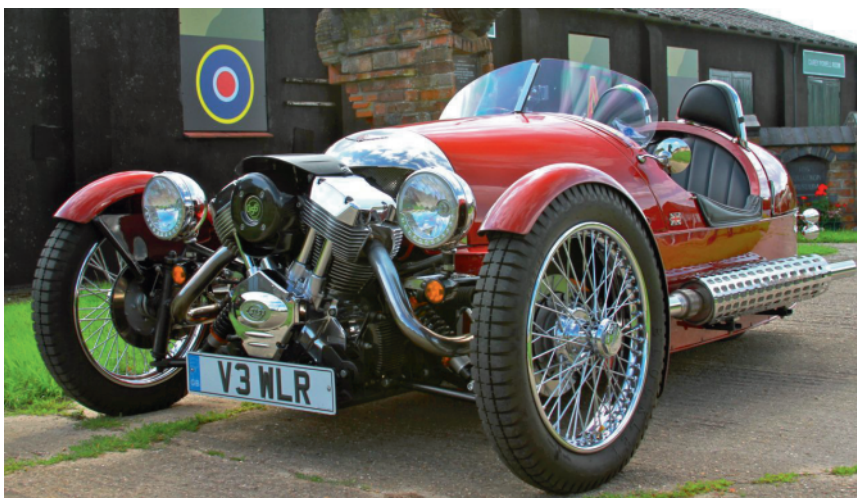
*Figure 8 2013 M3W fitted with Garage56 exhaust and air filter.  
(Photo by Simon Goldsworthy)*

This has its own design of ‘Spitfire’ air filter which takes the standard filter element but has an air scoop for a ram air effect. The exhaust system is larger than standard, with its own brackets and shields. Being an absorption system it has no internal baffles and is quieter with a deep rumbling tone. It is well made and has an extra flexible joint in the front pipe to help isolate the engine movement. It is reliable with good customer service from G56.

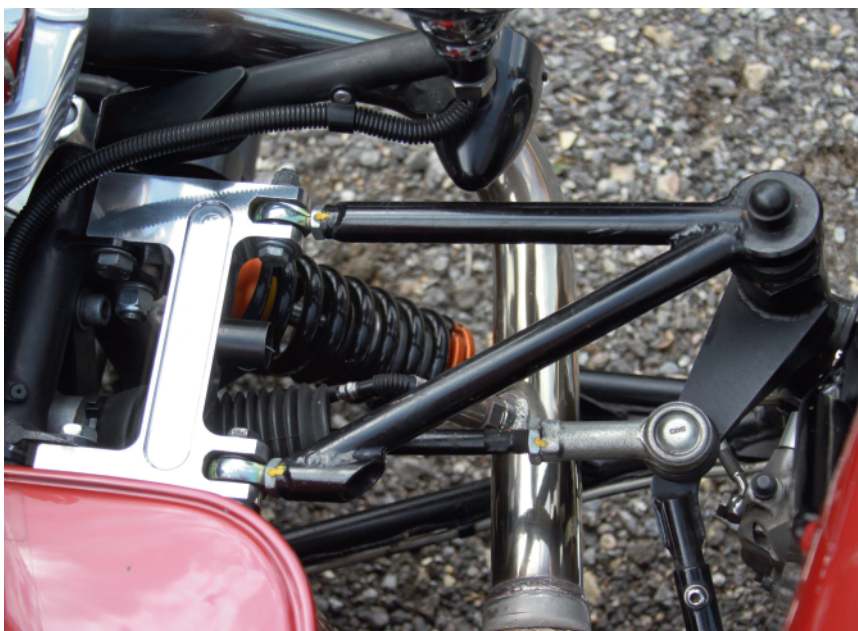
*Figure 9 Empire kit adjustable top wishbone. Also shows a ATR shock absorber.  
(Photo by Simon Goldsworthy)*

This is a desirable feature as it allows the suspension to be accurately set with adjustable caster and camber angles, improving the steering feel. Check the condition of the rod end bearings as they can wear but are easily replaced.
